HOME REPORT

6 BARNHILL
HARDTHORN ROAD
DUMFRIES
DG2 9TQ

Energy Performance Certificate (EPC)

6 BARNHILL, HARDTHORN ROAD, DUMFRIES, DG2 9TQ

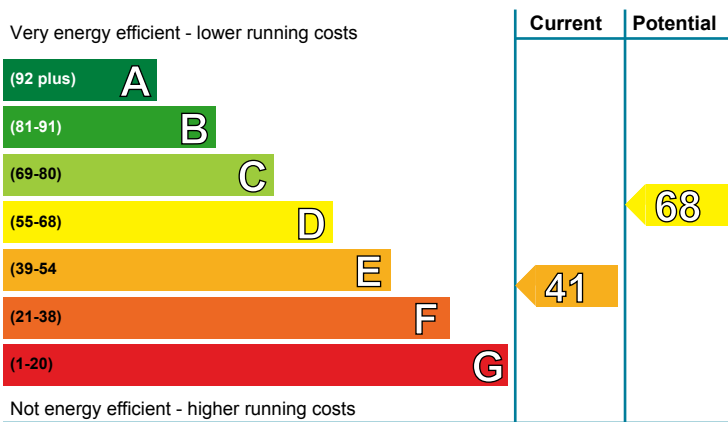
Energy Efficiency Rating

This graph shows the current efficiency of your home, taking into account both energy efficiency and fuel costs. The higher this rating, the lower your fuel bills are likely to be.

Your current rating is **band E (41)**. The average rating for EPCs in Scotland is **band D (61)**.

The potential rating shows the effect of undertaking all of the improvement measures listed within your recommendations report.

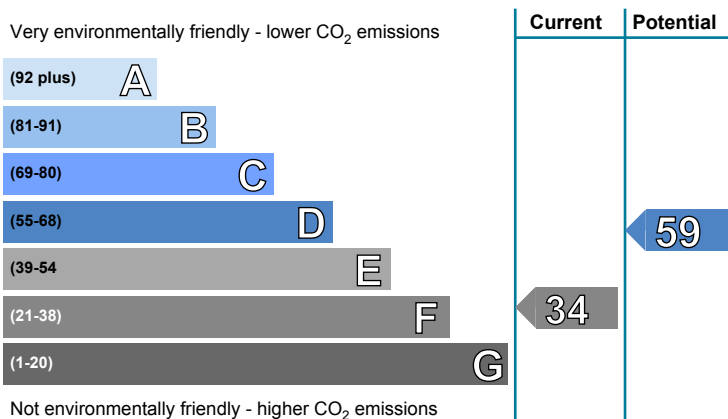
Environmental Impact (CO₂) Rating

This graph shows the effect of your home on the environment in terms of carbon dioxide (CO₂) emissions. The higher the rating, the less impact it has on the environment.

Your current rating is **band F (34)**. The average rating for EPCs in Scotland is **band D (59)**.

The potential rating shows the effect of undertaking all of the improvement measures listed within your recommendations report.
