HOME REPORT

BARBAIN KIRKPATRICK DURHAM

CASTLE DOUGLAS
DG7 3HS

Single Survey

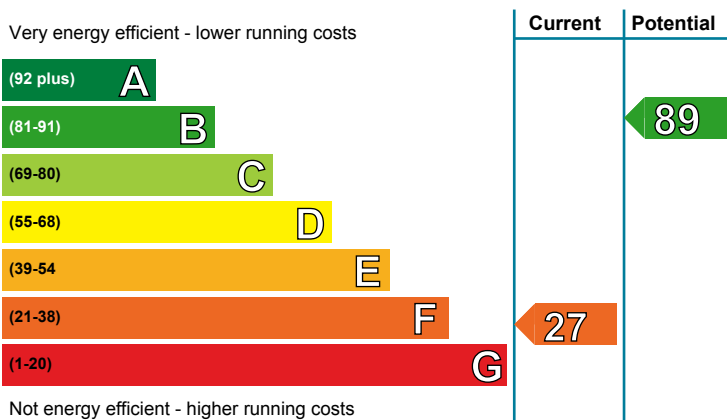
Energy Efficiency Rating

This graph shows the current efficiency of your home, taking into account both energy efficiency and fuel costs. The higher this rating, the lower your fuel bills are likely to be.

Your current rating is **band F (27)**. The average rating for EPCs in Scotland is **band D (61)**.

The potential rating shows the effect of undertaking all of the improvement measures listed within your recommendations report.

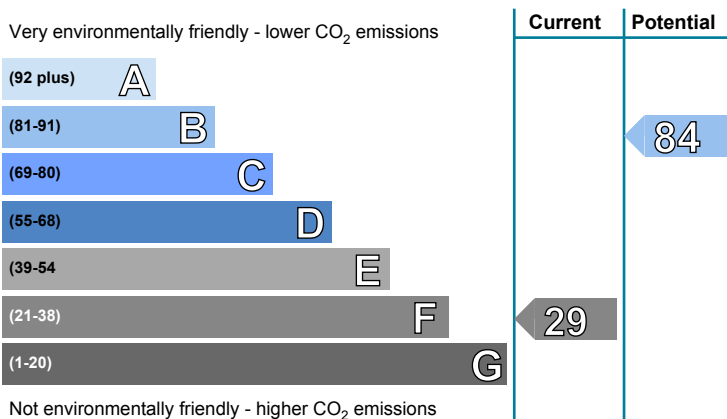
Environmental Impact (CO₂) Rating

This graph shows the effect of your home on the environment in terms of carbon dioxide (CO₂) emissions. The higher the rating, the less impact it has on the environment.

Your current rating is **band F (29)**. The average rating for EPCs in Scotland is **band D (59)**.

The potential rating shows the effect of undertaking all of the improvement measures listed within your recommendations report.
