# Home Report

# Single Survey

<b>Property address</b>	62 High Street Gatehouse Of Fleet Castle Douglas DG7 2HP
<b>Customer</b>	Andrew & Sheila McKean
<b>Customer address</b>	62 High Street Gatehouse Of Fleet Castle Douglas DG7 2HP
<b>Prepared by</b>	Shepherd Chartered Surveyors
<b>Date of inspection</b>	31/07/2024

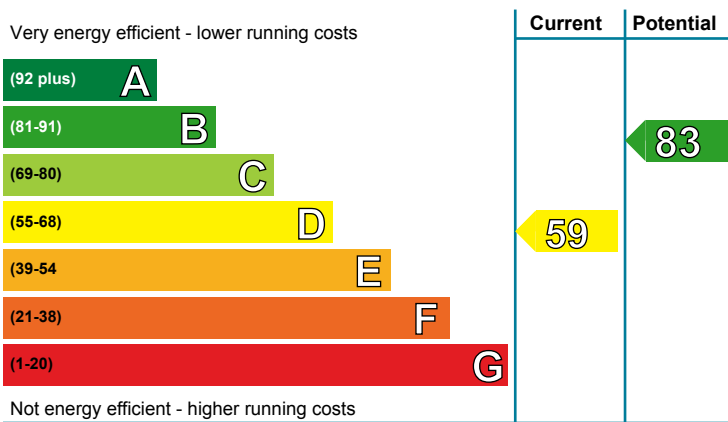
## Energy Efficiency Rating

This graph shows the current efficiency of your home, taking into account both energy efficiency and fuel costs. The higher this rating, the lower your fuel bills are likely to be.

Your current rating is **band D (59)**. The average rating for EPCs in Scotland is **band D (61)**.

The potential rating shows the effect of undertaking all of the improvement measures listed within your recommendations report.

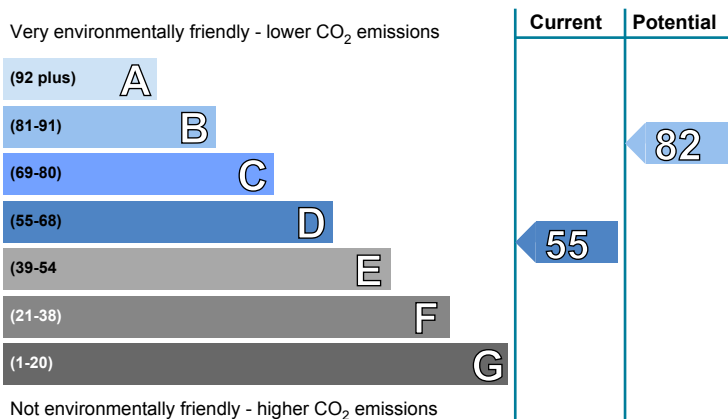
## Environmental Impact (CO<sub>2</sub>) Rating

This graph shows the effect of your home on the environment in terms of carbon dioxide (CO<sub>2</sub>) emissions. The higher the rating, the less impact it has on the environment.
