# Home Report

# Scottish Single Survey

<b>Property address</b>	Tarff Church Twynholm Kirkcudbright DG6 4NQ
<b>Customer</b>	Layna & Rory Gould
<b>Customer address</b>	Tarff Church Twynholm Kirkcudbright DG6 4NQ
<b>Prepared by</b>	Shepherd Chartered Surveyors
<b>Date of inspection</b>	15/08/2024

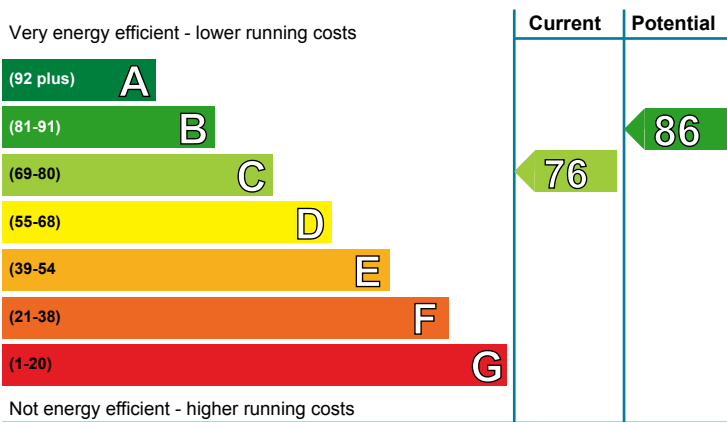
## Energy Efficiency Rating

This graph shows the current efficiency of your home, taking into account both energy efficiency and fuel costs. The higher this rating, the lower your fuel bills are likely to be.

Your current rating is **band C (76)**. The average rating for EPCs in Scotland is **band D (61)**.

The potential rating shows the effect of undertaking all of the improvement measures listed within your recommendations report.
