# Home Report

# Scottish Single Survey

<b>Property address</b>	174 King Street Castle Douglas DG7 1DA
<b>Customer</b>	Mrs Marion Owen
<b>Customer address</b>	174 King Street Castle Douglas DG7 1DA
<b>Prepared by</b>	Shepherd Chartered Surveyors
<b>Date of inspection</b>	14/08/2024

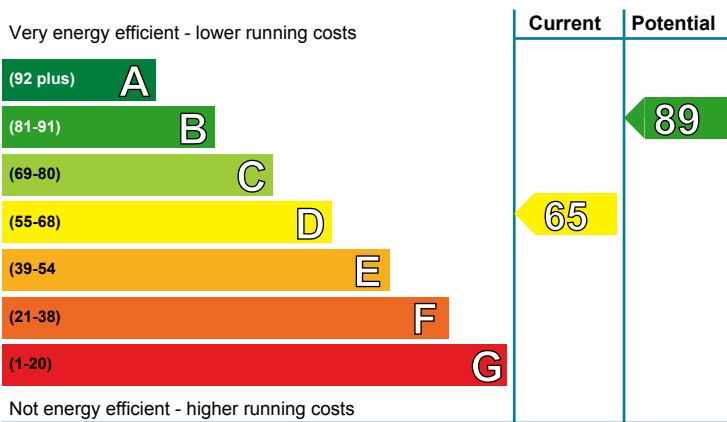
## Energy Efficiency Rating

This graph shows the current efficiency of your home, taking into account both energy efficiency and fuel costs. The higher this rating, the lower your fuel bills are likely to be.

Your current rating is **band D (65)**. The average rating for EPCs in Scotland is **band D (61)**.

The potential rating shows the effect of undertaking all of the improvement measures listed within your recommendations report.

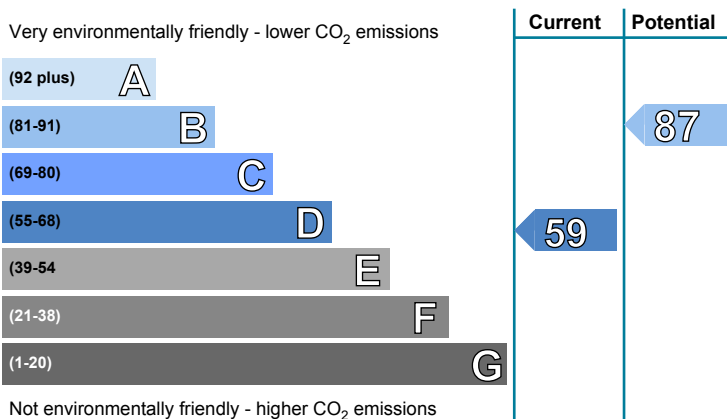
## Environmental Impact (CO<sub>2</sub>) Rating

This graph shows the effect of your home on the environment in terms of carbon dioxide (CO<sub>2</sub>) emissions. The higher the rating, the less impact it has on the environment.

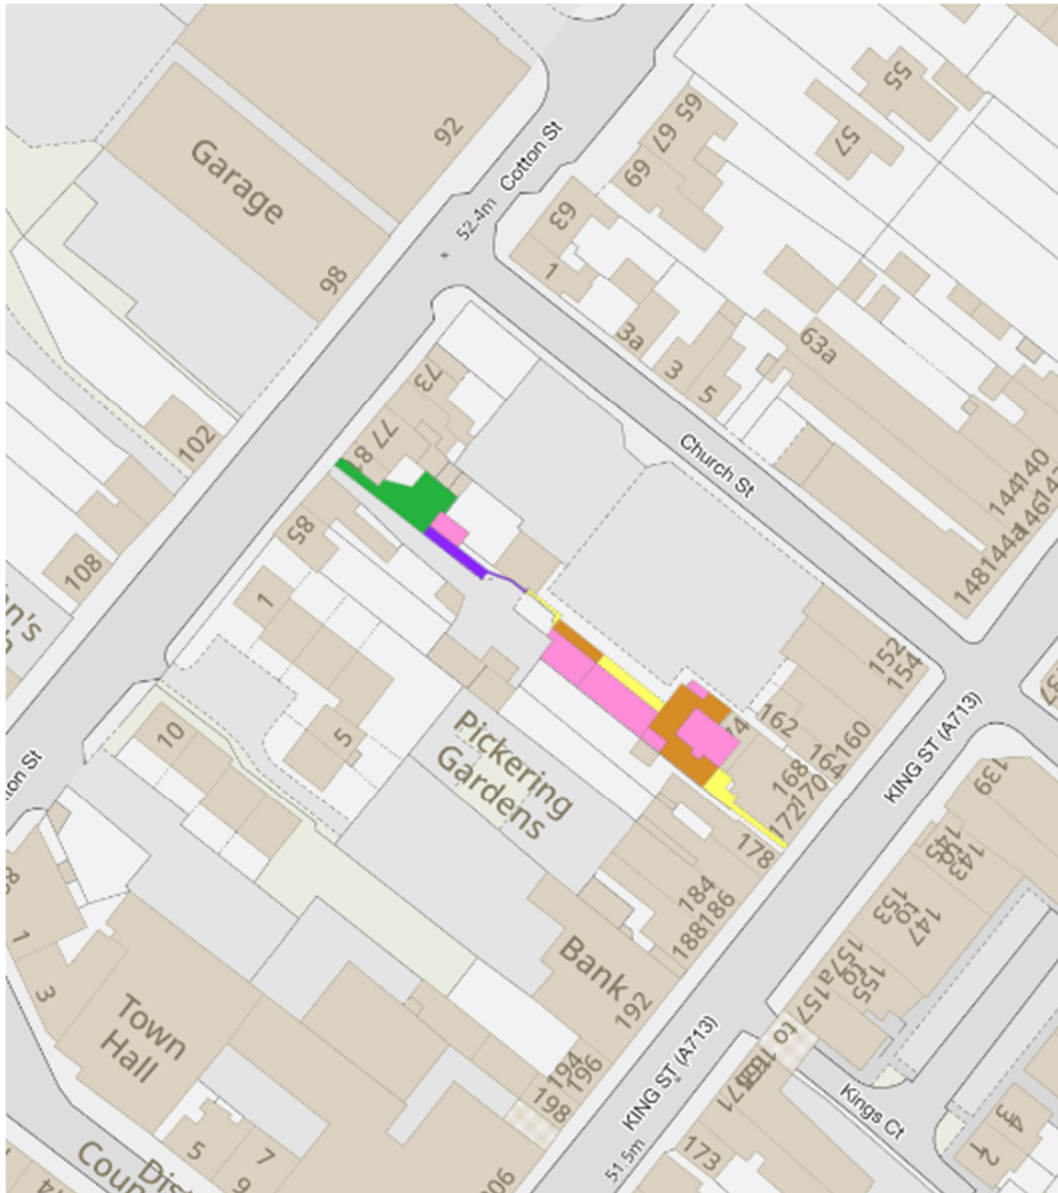
Pink tinted areas – house, washhouse, coalhouse, garden ground and garage (owned by 174)

Brown tinted areas – owned by 174, but 170 and 172 King Street have access rights over it
