Scottish Single Survey

Property address	2 Meikle Breconside Cottages Kirkgunzeon Dumfries DG2 8JN
------------------	--

Date of inspection	06/09/2024

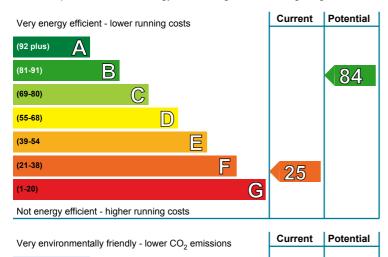
Estimated energy costs for your home for 3 years*	£10,884	See your recommendations
Over 3 years you could save*	£3,567	report for more information

* based upon the cost of energy for heating, hot water, lighting and ventilation, calculated using standard assumptions
